Technical Paper

IEPC-2002-030 Interactions within a Cluster of Low Power Hall Thrusters

Interactions within a Cluster of Low Power Hall Thrusters

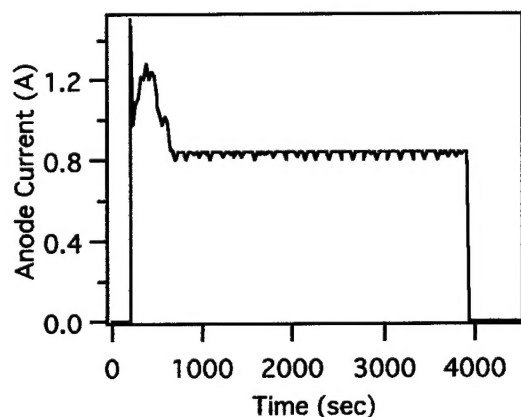
Fig. 2. Anode current trace characteristic of a start following exposure of the thruster to atmospheric conditions for several days. Duration of the anode current transient is 420 seconds. Note: initial current spike to 1.5 A is caused by start-up sequence.

Figure 2 shows a typical trace of the anode current during a start after the chamber has been open to atmosphere. The initial anode current spike (1.5 A) is due to the start procedure where the anode is current limited and the magnet is off. After the magnet current is switched to its nominal value, the transient consists of anode currents as much as 50% greater than the nominal value of 830 mA lasting approximately 300 to 500 seconds. The anode current transient only occurs for the first 300-500 seconds and does not return on start after the thruster has been conditioned. With subsequent exposure, the transient returns. Figure 3 shows that this behavior persists if the thruster anode discharge is cycled during the time period associated with the anomaly. Interestingly, the thrust level during the period of the anode current transient is unchanged. The 50% increase in anode current simply reduces the efficiency by a like amount.

The effect shown in Figs. 2 and 3 occurs under two distinct circumstances. First, it occurs when the chamber has been opened to atmosphere, exposing the thrusters to ambient air. Second, it occurs when the chamber pumps have been turned off, allowing the cryo-panels to regenerate, exposing the thrusters to a 0.5 Torr 'dirty' vacuum. In the latter case, the cryo-pump is valved off from the chamber, then it and the cryo-panels are allowed to warm to room temperature. The chamber pressure rises to approximately 0.5 Torr (N_2). The atmosphere within the chamber is assumed to consist of primarily xenon gas sublimated from the cryo-panels and water which was trapped by the panels during the initial pump down. However, molecular oxygen can be pumped by the cryo-panels at 25 K, so there may be substantial oxygen and nitrogen in the chamber as well [5]. The atmosphere within the chamber during this conditions will be sampled in future tests. Subsequent use of the chamber does not require repressurization to atmosphere. The chamber may be roughed to approximately 30 mTorr (N_2) at which time the cryo-pump and cryo-panels are activated.

The duration of the anomalous anode current transient appears to depend on the degree of exposure to the atmosphere, or gases sublimated from the pumping surfaces. If exposed to atmospheric conditions for several days, the anode current will return to the nominal 830 mA within 500 seconds. Subsequent exposures to the regenerated vacuum appear to reduce the length of the anode current transient by approximately 20%. For example, thruster 1 was started after exposure to atmosphere and the initial transient persisted for 425 seconds. The chamber was cycled without being opened to atmosphere and the subsequent current transient lasted 340 seconds. This chamber was again cycled without being opened and the anode current transient persisted for only 255 seconds. This trend is typical of all four thrusters in this study.

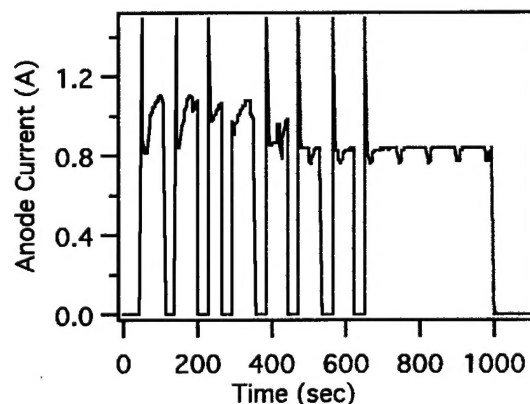
Fig. 3. Anode current trace of the transient with a number of nominally 60 second firings spaced 30 seconds apart. The anomaly persisted for approximately 4.25 min. Note that the thruster has been exposed to regenerated cryo-panel products for a period of 12 days and not exposed to atmosphere.

There are actually two effects shown in Figs. 2 and 3. The anode current transient is accompanied by a periodic (~60 sec) dip in the anode current. Figure 3 shows quite clearly that this period is not affected by the thruster on/off condition. This behavior has been correlated to the pressure fluctuations in the propellant lines of the thruster. The general effect has been documented previously [6]. Due to the low flow of propellant from the pressure bottle through the MFC, the bottle pressure regulator is opening causing a pressure increase in the lines between the regulator and the MFC. The valve on the regulator then closes until the pressure drops by some fraction of the set pressure and then the process repeats. The MFC responds to these periodic increases

in upstream pressure and overcompensates, reducing the flow rate. This overcompensation is due to the flow sensing element being upstream of the throttling valve in the MFC. The MFC does not recognize that it has over compensated and for approximately 3 seconds the flow is reduced by approximately 10%, reducing the anode current by a similar fraction. Efforts are underway to eliminate this issue.

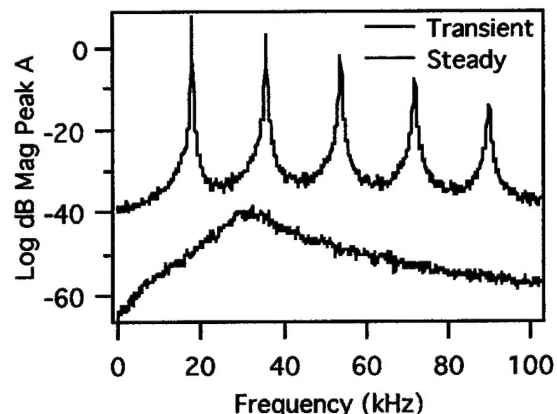
Fig. 4. Two spectra of current oscillations. The first during the transient with an average current of 1.14 A, and the second during steady state operation with an average current of 0.84 A.

The frequency of the anode current oscillations during a start were measured using Tektronix TCP202 current probes and an TEK1103 probe power supply connected to an Stanford Research Systems SR785 dynamic signal analyzer (DC-104 kHz). A plot of the oscillatory behavior during the anode current transient given in Fig. 4 and compared to the steady state behavior. During the period of anomalous anode current, we see a strong frequency response at approximately 18 kHz and what appear to be 4 harmonics. This behavior is radically different than the steady state behavior also shown in Fig. 4. In the steady state case, there is only a single broad peak at approximately 25 kHz. The steady state spectra is significantly less energetic with peak magnitudes approximately 20 dBA less than the transient case shown in Fig. 4.

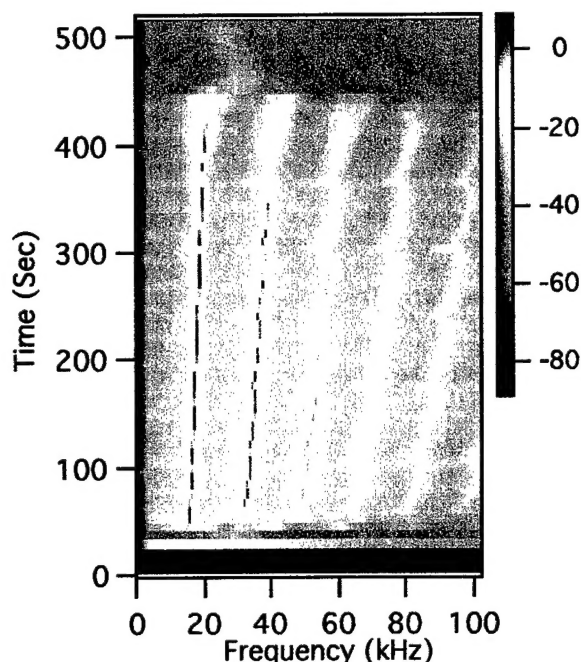
Fig. 5. Contour plot showing the time evolution of the anode Log Magnitude Peak Current (dBA) during a start where the anode current transient is present.

Figure 5 shows the time evolution of the anode current frequency spectrum. Although the frequencies of the major features are increasing slightly and the higher orders are decreasing in magnitude, these frequency components retain significant power until they collapse into the steady state single broad peak at 25 kHz. The periodic shifts in the peaks correspond to periods of lowered propellant flow during the pressure regulator approximately 60 second cycle.

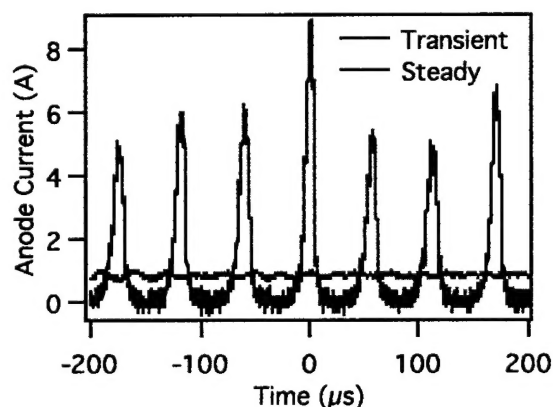
Fig. 6. Current oscillations of the transient and steady state cases seen in the time domain. Conditions are analogous to those in Fig. 4.

oscilloscope. Figure 6 shows the difference between the steady state behavior and the behavior during the anode current transient. During steady state, there is a strong DC anode current component overlaid by a weak 25 kHz component. The behavior during the anode current transient is nearly the opposite. The anode current is primarily AC with peaks measured as high as 9 A. In this mode of operation, the thruster is literally turning itself on and off every 50-60 μ s.

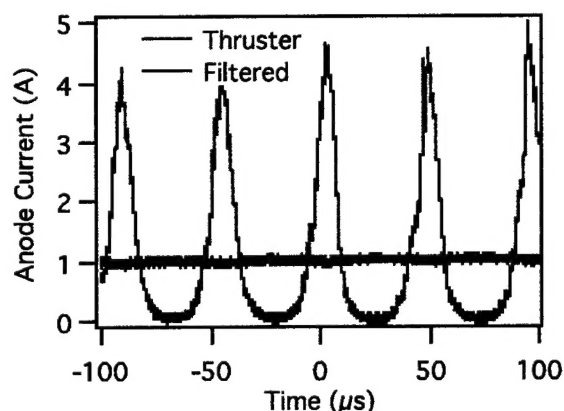
Fig. 7. Current oscillations during the anode current start transient as seen at the thruster and behind the filter at the power supply.

The effect of the LC filter is shown in Fig. 7 where we see the current measured at the thruster compared to the

current trace on the power supply side of the filter. The thruster anode sees 18 kHz on/off behavior, while the power supply does not see the oscillations. The LC circuit shields the power supplies exposure to the oscillations by 30 to 50 dB. The use of the LC circuit is not strictly necessary since the inherent impedance of the power supplies produces a similar filtering. Here, the filter is used to provide an additional degree of isolation.

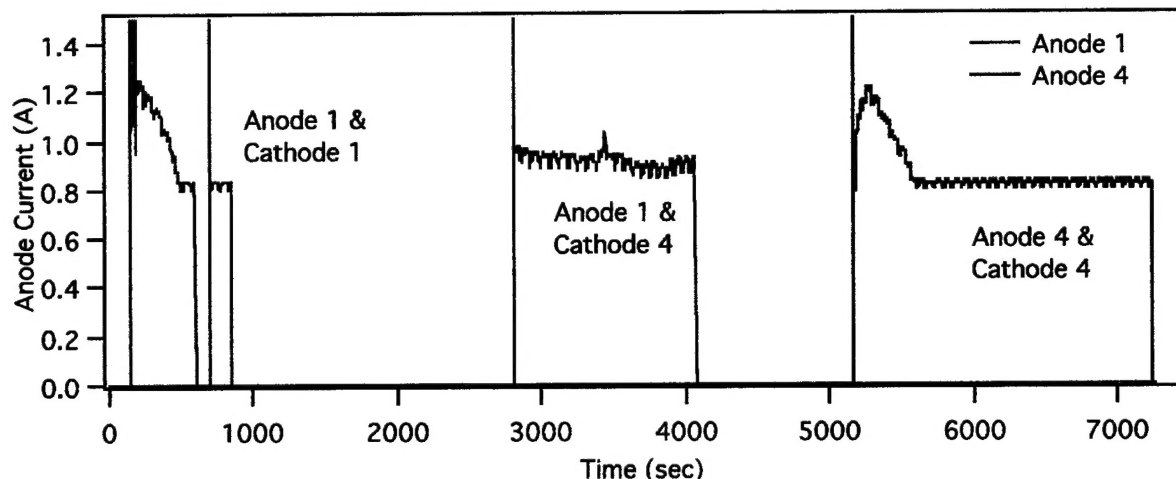
Fig. 8. Firing of anode 1 with cathode 1 and cathode 4 compared to the firing of anode 4 with cathode 4. Note that when anode 1 is fired with cathode 4, the coupling of the anode cathode is inferior to the nominal case, presumably since cathode 4 is not adjacent to anode 1.

As a result of the first three tests, the anode current transient had not been isolated to either the cathode or the anode; however, the effect did appear to require significant exposure time (hours) to manifest itself. The conclusive test was performed by taking advantage of the cluster of four Hall thrusters and their relative proximity within the vacuum facility. In this test, two unconditioned, adjacent thrusters, 1 and 4, were fired in the following sequence. First, thruster 1 was started using cathode 1, and fired for a sufficient time to condition the thruster. Then, the thruster was shut down and

restarted briefly to confirm its conditioning. At this time, cathode 4 (the cathode nominally attached to thruster 4) was substituted electrically for cathode 1. Anode 1 with cathode 4 was subsequently started. At this time, no anode current anomaly was detected. As a control, cathode 4 was electrically reconnected to anode 4 and fired. This resulted in a typical example of the anode anomalous behavior. The anode currents measured during this sequence are illustrated in Fig. 8.
